INDOOR AIR QUALITY ASSESSMENT

**Board of Higher Education
McCormack Building
14th Floor
Room 1401
Boston, MA**

Prepared by:
Massachusetts Department of Public Health
Bureau of Environmental Health Assessment
August 2002

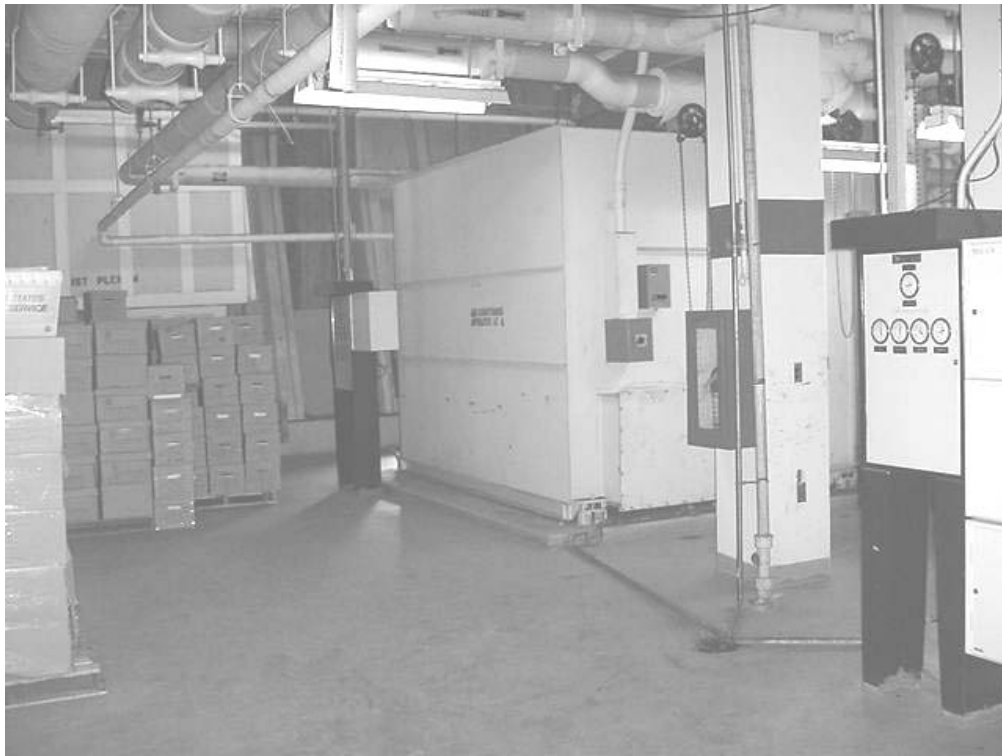
Picture 1

AHU for 14th Floor in Rooftop Mechanical Room

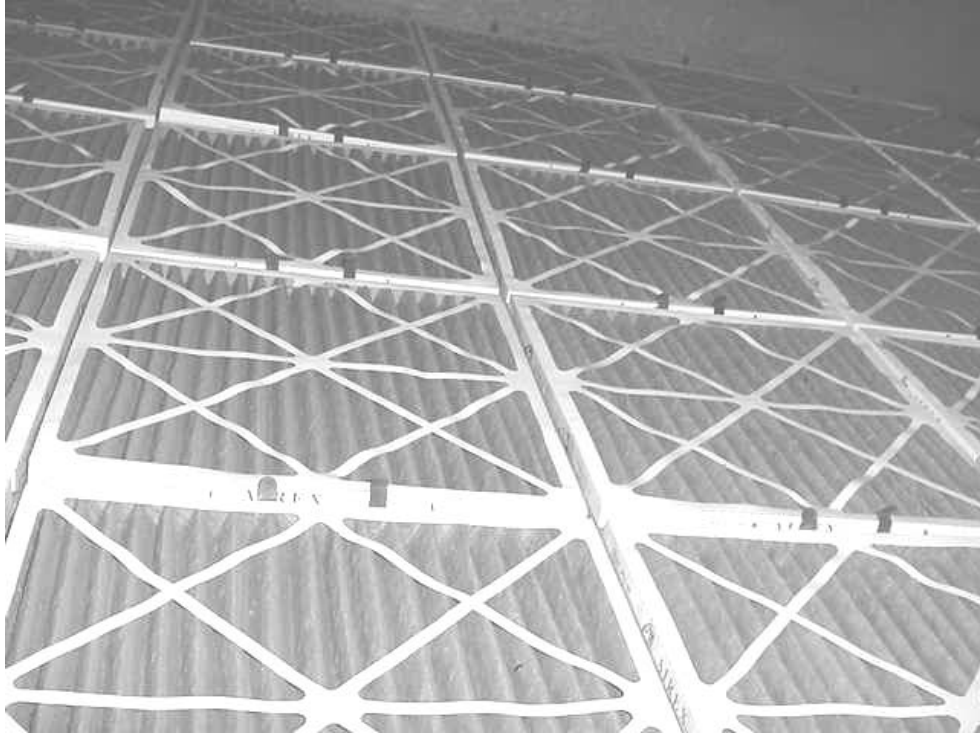
Picture 2

First of Two Filter Banks for HVAC System

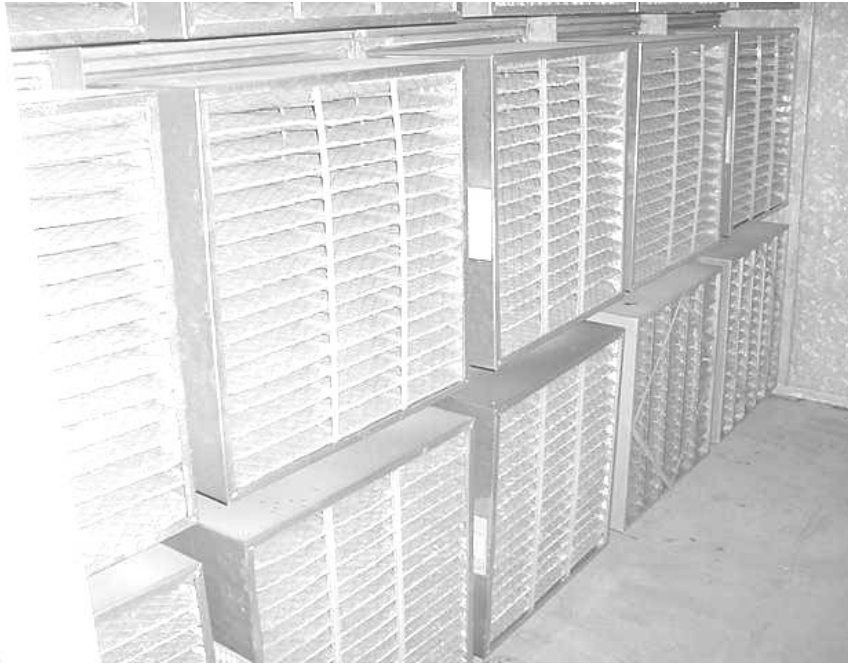
Picture 3

Second Filter Bank for HVAC System

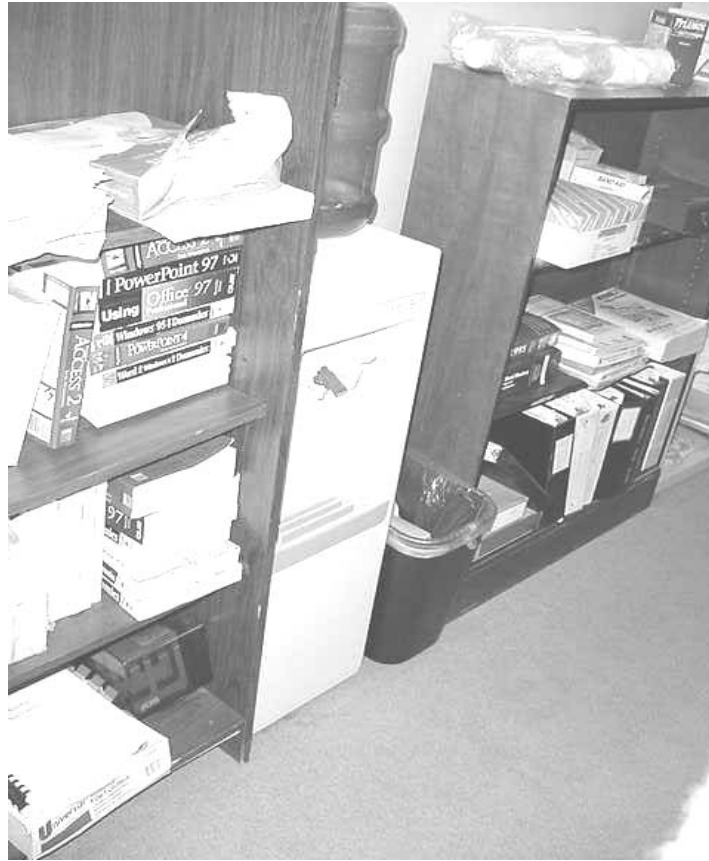
Picture 4

Several areas had water coolers installed over carpeting (see Picture 4). Water spillage or overflow of cooler catch basins can result in the wetting of the carpet. The American Conference of Governmental Industrial Hygienists (ACGIH) recommends that carpeting be dried with fans and heating within 24 hours of becoming wet (ACGIH, 1989). If carpets are not dried within this time frame, mold growth may occur.

Water Cooler on Carpeting

5. Place rubber/plastic matting beneath water cooler to prevent water damage to carpeting.
6. Replace damaged/dislodged ceiling tiles to prevent the egress of dirt, dust and particulate matter into occupied areas.

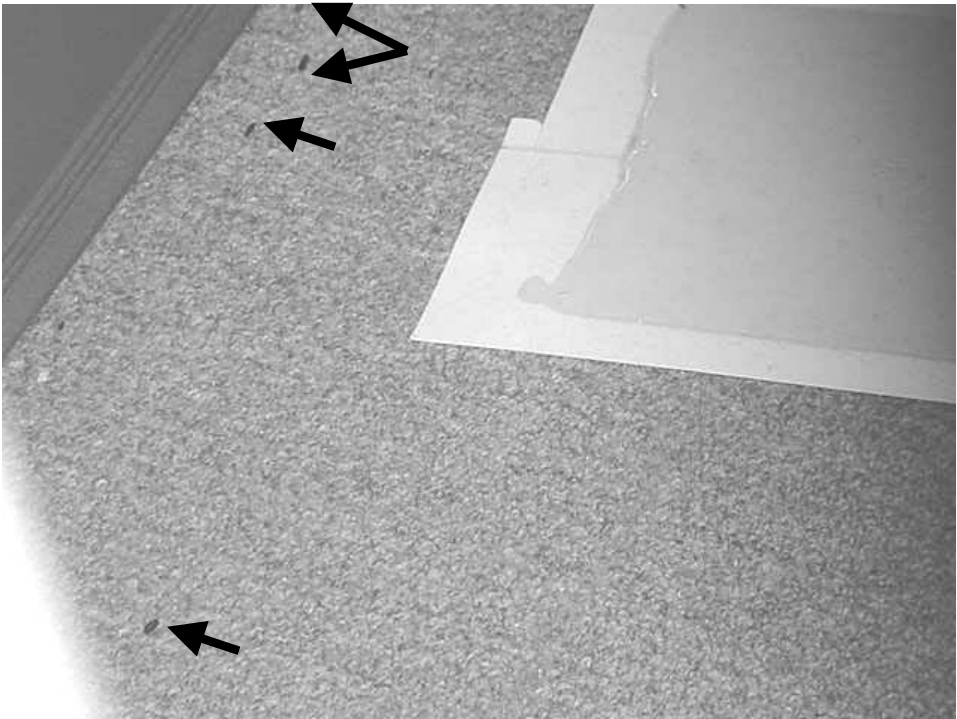
Picture 5

Periodic rodent sightings were also reported to BEHA staff. Pest traps and rodent droppings were noted in several offices and common areas (see Pictures 5 & 6). Rodent infestation can result in indoor air quality related symptoms due to materials in their wastes. Mouse urine contains a protein that is a known sensitizer (US EPA, 1992). A sensitizer is a material that can produce symptoms readily in sensitive individuals. A three-step approach is necessary to eliminate rodent infestation:

Pest Trap and Rodent Droppings

1. removal of the rodents;

2. cleaning of waste products from the interior of the building; and
3. reduction/elimination of pathways/food sources that are attracting rodents.

To eliminate exposure to allergens, rodents must be removed from the building. Please note that removal, even after cleaning, may not provide immediate relief since allergens can exist in the interior for several months after rodents are eliminated (Burge, H.A., 1995). A combination of cleaning, with an increase in ventilation and filtration should serve to reduce rodent associated allergens once the infestation is eliminated.

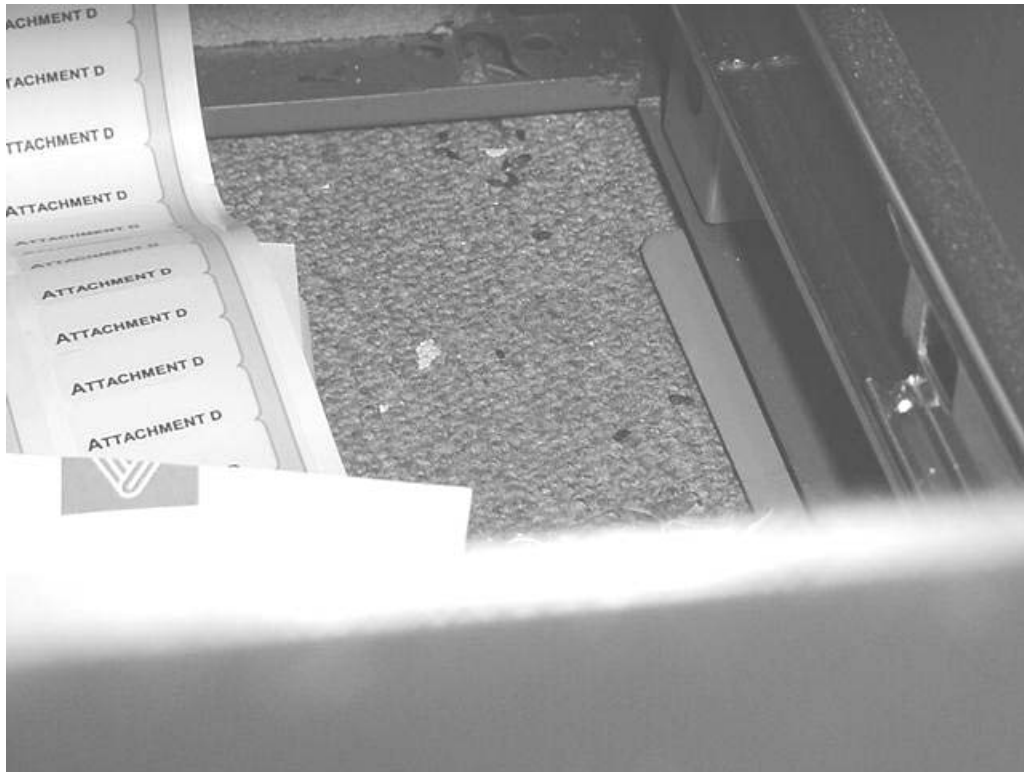
Picture 6

**Rodent Droppings beneath Drawer of File Cabinet in Employee's Cubicle
Outside of (Weening) Office**

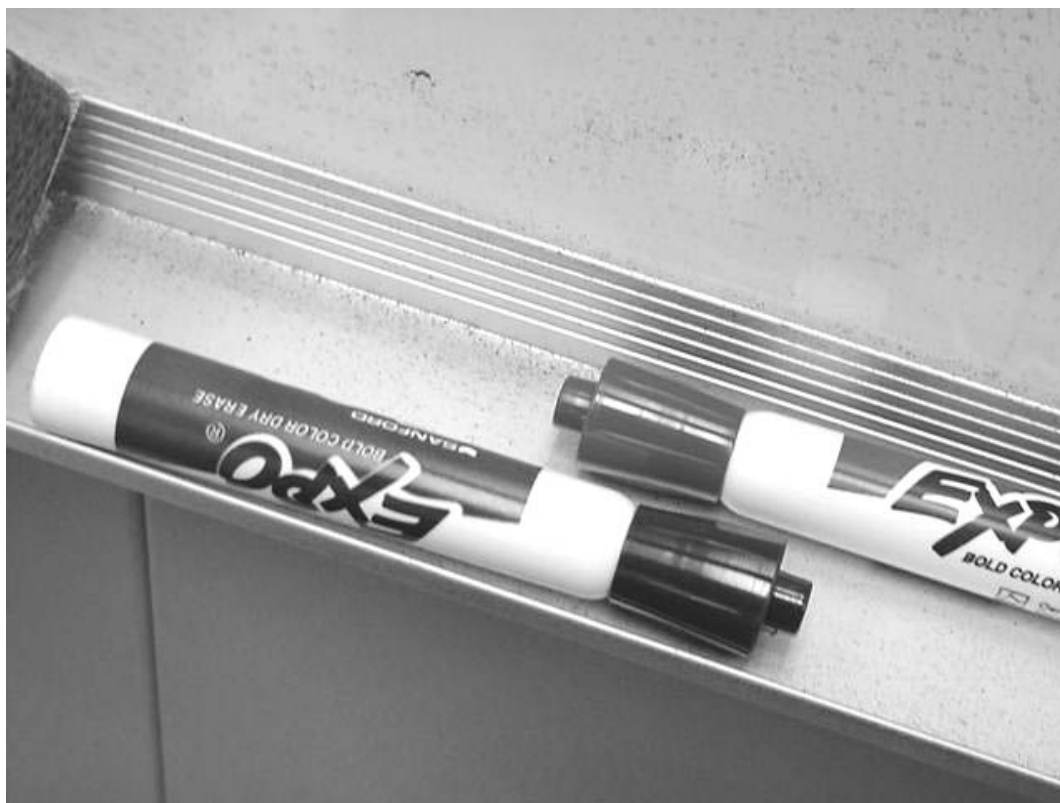
Picture 7

Several areas contain dry erase boards and markers. Accumulated dry erase board particulate was noted in a few areas (see Picture 7). Several rooms also had damaged and/or dislodged ceiling tiles. Missing/dislodged ceiling tiles can provide a pathway for the movement of drafts, dusts and particulate matter between rooms and floors. Dry erase board particulate can be easily aerosolized and serve as eye and respiratory irritants. In addition, materials such as dry erase markers and dry erase board cleaners may contain VOCs (e.g., methyl isobutyl ketone, n-butyl acetate and butyl-cellusolve) (Sanford, 1999), which can also be irritating to the eyes, nose and throat.

Dry Erase Board Markers and Particulates

8. Clean dry erase board trays regularly to avoid the build-up of particulates.
9. Continue to change HVAC filters on current schedule or more frequently if needed. Vacuum interior of FCU prior to activation to prevent the aerosolization of dirt, dust and particulates.

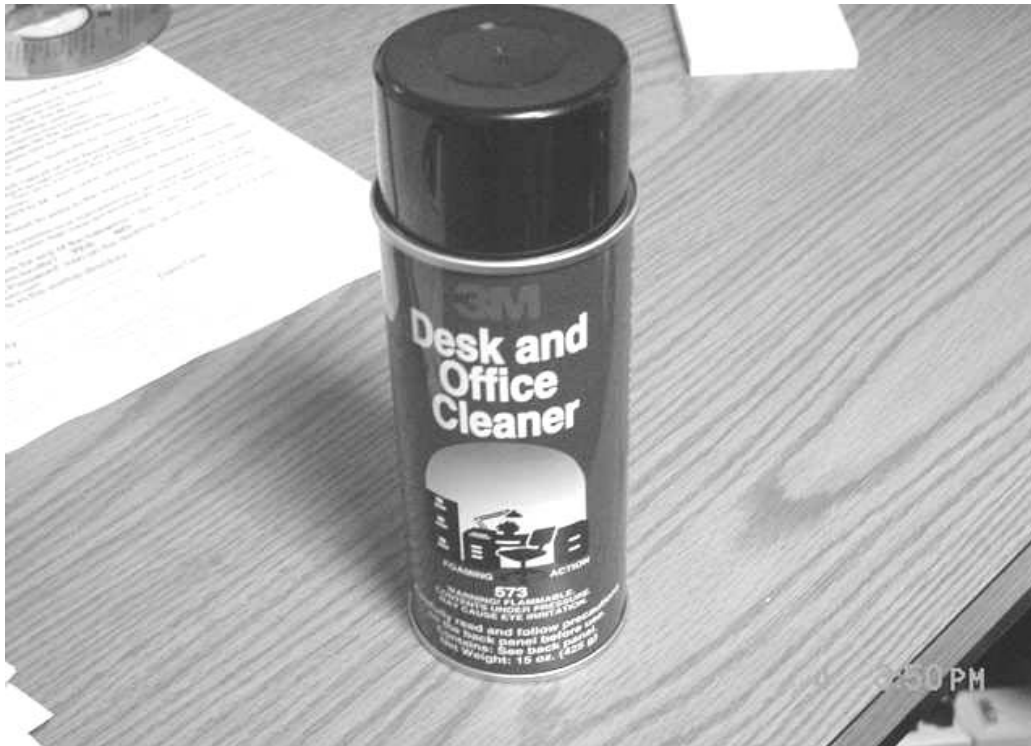
Picture 8

BEHA staff observed a number of VOC-containing cleaning materials that BHE personnel use to clean personal work areas. A strong odor of lemon furniture polish was noted in the conference room. The material shown in Pictures 8 & 9 contains several VOCs (e.g., isopropyl alcohol and monoethanolamine) that can be irritating to the eyes, nose and throat (3M, 2000). These materials, in combination with those conditions discussed earlier (e.g., potting soil/plants on FCUs, accumulated items/dust, rodent allergens) if considered individually present conditions that could degrade indoor air quality. When combined, these conditions can serve to exacerbate conditions leading to eye irritations and other indoor air quality comfort complaints.

VOC-Containing Cleaning Material

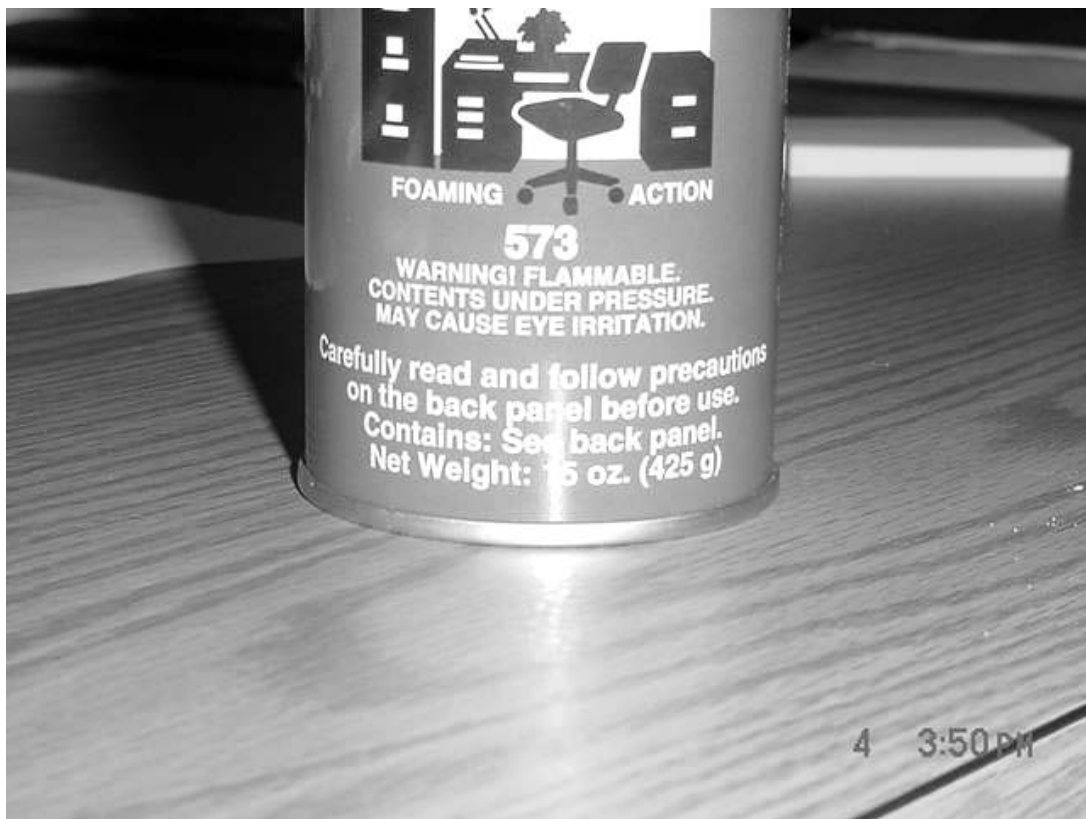
Picture 9

Close-up of Warning Label on Cleaning Material in Previous Picture
